Subject: Supplemental Licensee Event Report 2012-001-01, "Unit 2 Loss of Normal Offsite Power and Reactor Trip and Unit 1 Loss of Normal Offsite Power Due to Failure of System Auxiliary Transformer Inverted Insulators"

Byron Station, Unit 1

4. TITLE

Unit 2 Loss of Normal Offsite Power and Reactor Trip and Unit 1 Loss of Normal Offsite Power Due to Failure of System Auxiliary Transformer Inverted Insulators

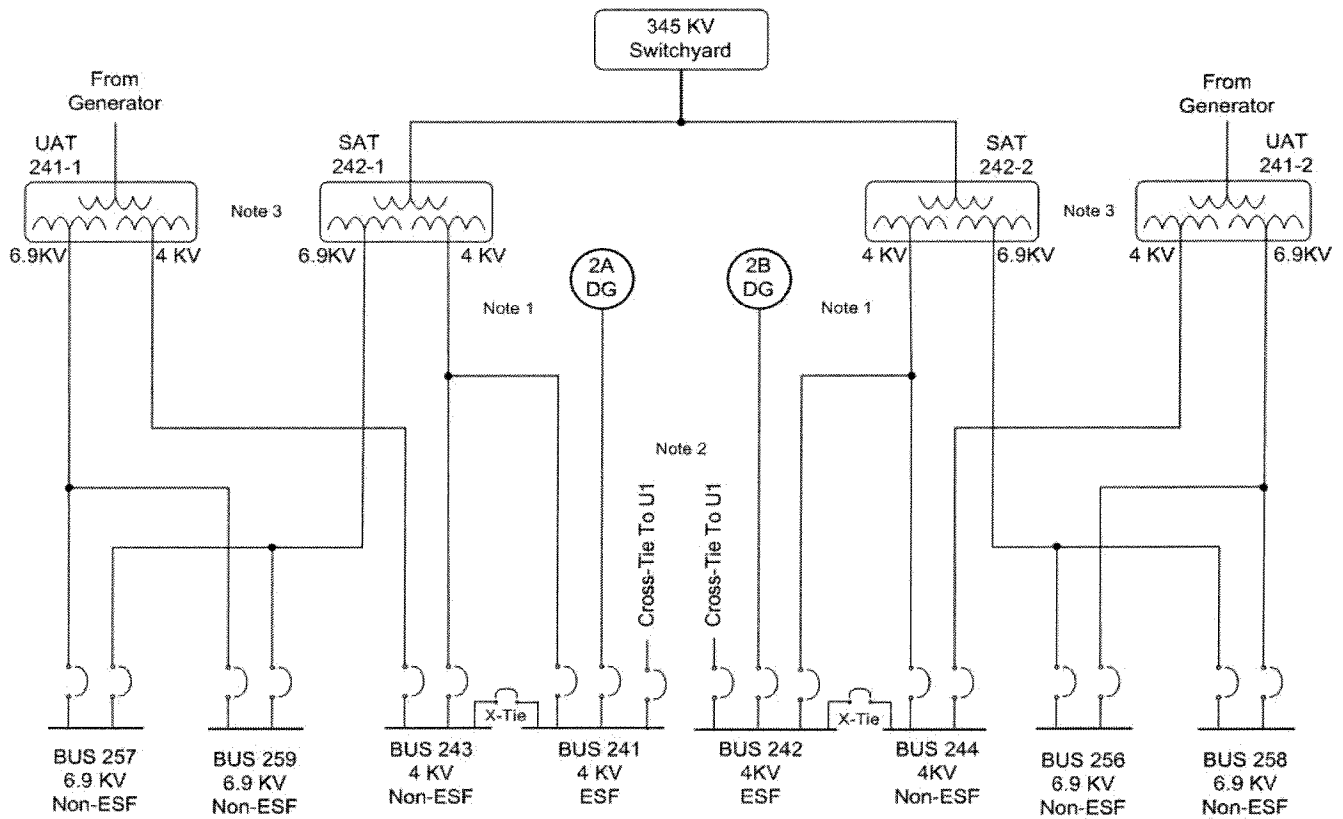
Figure 1

Unit 1 and Unit 2 AC Electrical Power Design Summary (see figure 1)

The Unit 1 and Unit 2 AC electrical system consists of two 4.16 kilovolt (kV) Engineered Safety Features (ESF) buses, four nonsafety-related 6.9 kV buses and two nonsafety-related 4.16 kV buses. The two 4.16 kV ESF buses and two of the nonsafety-related 6.9 kV buses normally are supplied by one of the two System Auxiliary Transformers (SATs) [EB] connected through one 345 kV offsite circuit. The remaining two nonsafety-related 6.9 kV station buses and two nonsafety-related 4.16 kV station buses normally are supplied by one of two Unit Auxiliary Transformers (UATs) [EL] when the main generator is online. The four Reactor Coolant Pumps (RCPs) are powered by the four 6.9 kV buses. Each 4.16 kV ESF bus has a dedicated standby emergency Diesel Generator (DG) [EK].
